**Section 7
Recommendations**

7.2 CONDITION ASSESSMENT RESULTS AND RECOMMENDATIONS

VICTOR VALLEY WASTEWATER RECLAMATION AUTHORITY
SEWER MASTER PLAN, MODELING AND CONDITION ASSESSMENT

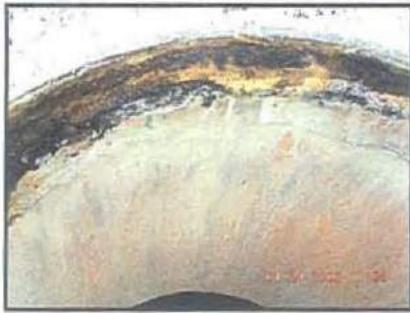
South Apple Valley Manhole #42
(Located in Outer Hwy 18)

It is speculated that the extensive corrosion in this particular section of Interceptor is directly related to the odor issues which have been a consistent nuisance along this stretch. This line is fed by two force mains originating from the Apple Valley (Nanticoke) and Otoe Pump Stations. These pump stations and force mains discharge raw sewage, at high velocity, into the SAV interceptor near its furthest upstream manholes. This can cause a release of Hydrogen Sulfides (H_2S) that has damaging corrosion effects on the Interceptor facilities. VVWRA has contracted with an outside consultant to conduct a study to determine the cause of the odors and potential remedies.

In conjunction with the manholes slated for cover and cover frame replacement, re-coating on the interior of the manholes is recommended for the many of these structures.

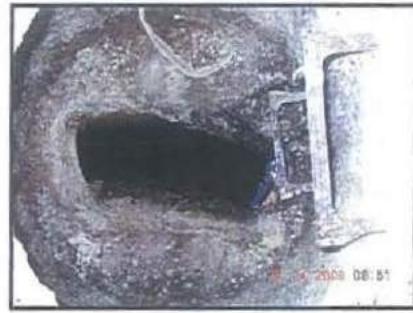
South Apple Valley Manhole #70
(Recommended for complete replacement)

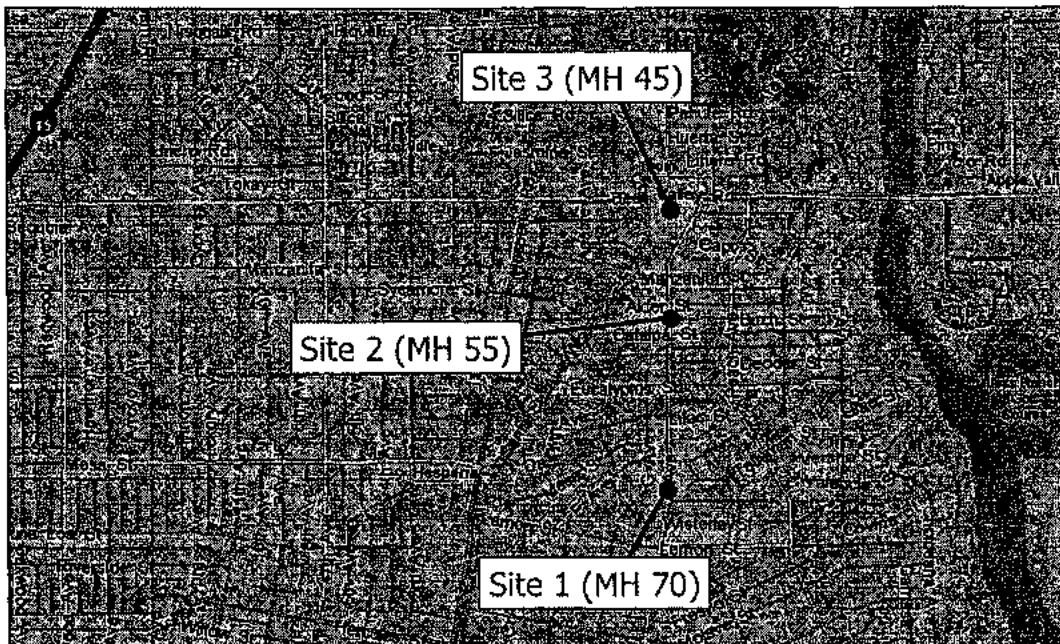
Figure 2. Street Map of Flow Monitoring Sites

Flow monitoring was conducted over a 7-day period from December 7, 2007 through December 14, 2007. The monitoring sites selected by RBF are shown in Figure 2:

- Site 1: A flow meter was installed in the upstream side of the 15-inch sanitary sewer pipe of Manhole 70, located on I Avenue, 1 manhole north of Valencia Street.
- Site 2: A flow meter was installed in the upstream side of the 18-inch sanitary sewer pipe of Manhole 55, located at the intersection of I Avenue and Birch Street.
- Site 3: A flow meter was installed in the upstream side of the 18-inch sanitary sewer pipe of Manhole 45, located off the public right of way, west of I Avenue and south of Bear Valley Road.

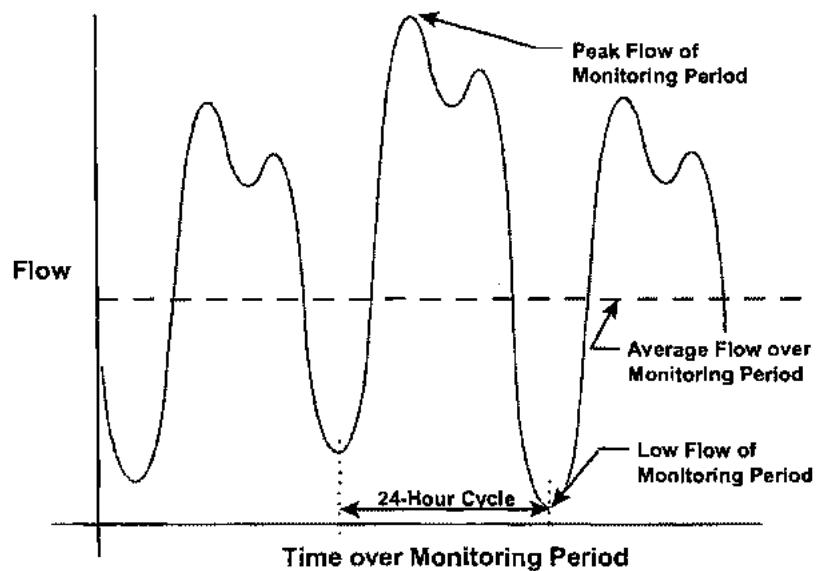
Figure 4. Diagram of Hypothetical Diurnal Flow over Monitoring Period

Flow versus time graphs are created by interpolating the data recorded by the flow meter in 15-minute intervals. They represent the diurnal flow curve recorded over a given monitoring period; the data in its rawest form. Figure 4 shows a typical diurnal flow curve. The hypothetical peak, low and average flows recorded over an example monitoring period are identified on this graph. These graphs are useful in identifying the extreme limits of the flows being monitored and pinpointing any trends that might be occurring at a particular site. Flow, level and velocity graphs versus time illustrate the actual recorded data over the monitoring period and are provided in *Appendix A* of this report.

Dry weather flow is caused by actual waste drainage from buildings in the area. Wet weather flow includes rain-dependent infiltration and inflow which may increase the flow through the sewer pipes. The flows recorded during this study were dry weather flows only. For this report, the peak and average flows during dry weather are abbreviated as follows: ADWF = Average Dry Weather Flow; PDWF = Peak Dry Weather Flow.

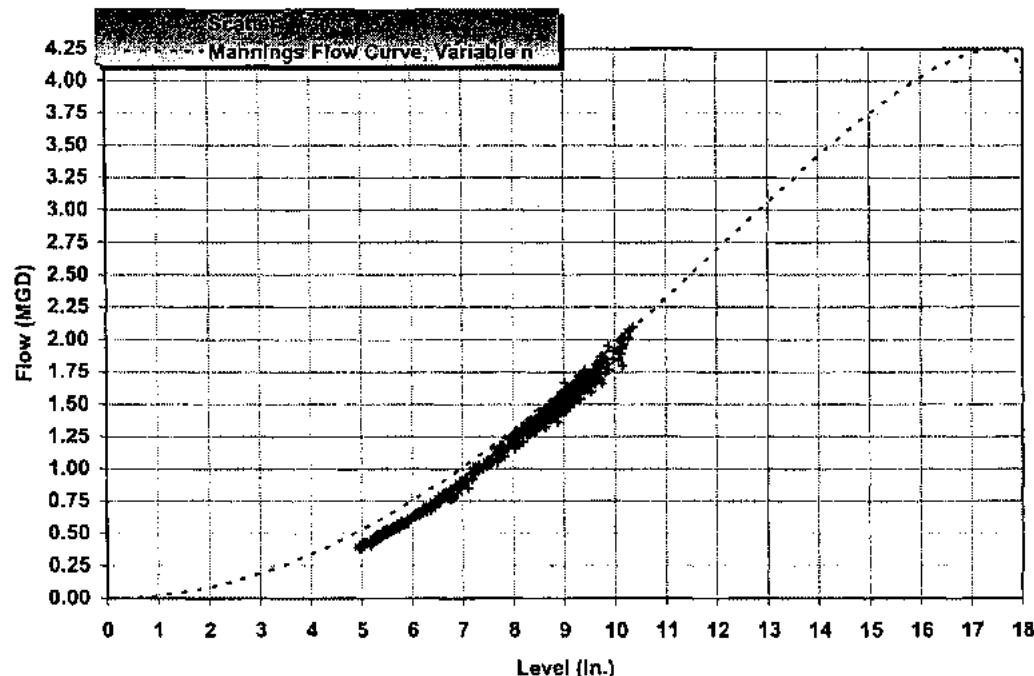
Figure 6. Site 2 Stage Curve

The pipeline capacity is estimated based upon the measured data from each flow metering site. The metered flow data is plotted over the Manning's Equation flow curve and extrapolated to a full-flow scenario, as shown in Figure 6 for Site 2. Table 3 shows the estimated capacity of the pipelines at all flow monitoring sites.
